NASA-DoD Lead-Free Electronics Project

Joint Test Report - Final

December 2011

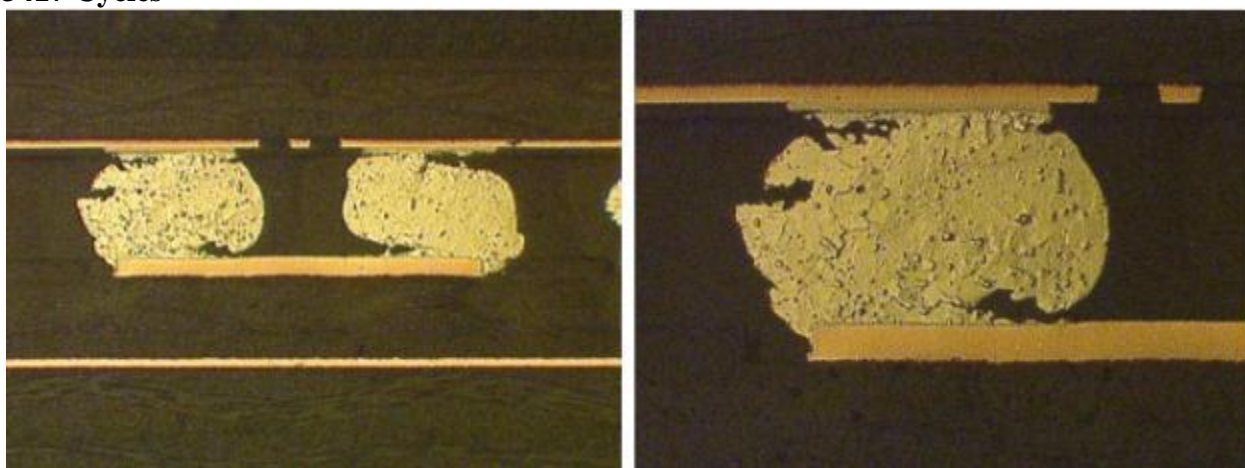
- The cracks in the solder joints were observed to have to failure modes: (1) initiation at the solder joint/component pad interface; (2) significant solder ball deformation with cracks at either solder joint component pad or solder joint/test vehicle pad interface.

Figure 165 - CSP-100 Solder Joints, Board 49, Component U60, SAC305/SAC105, Failed @ 3908 Cycles

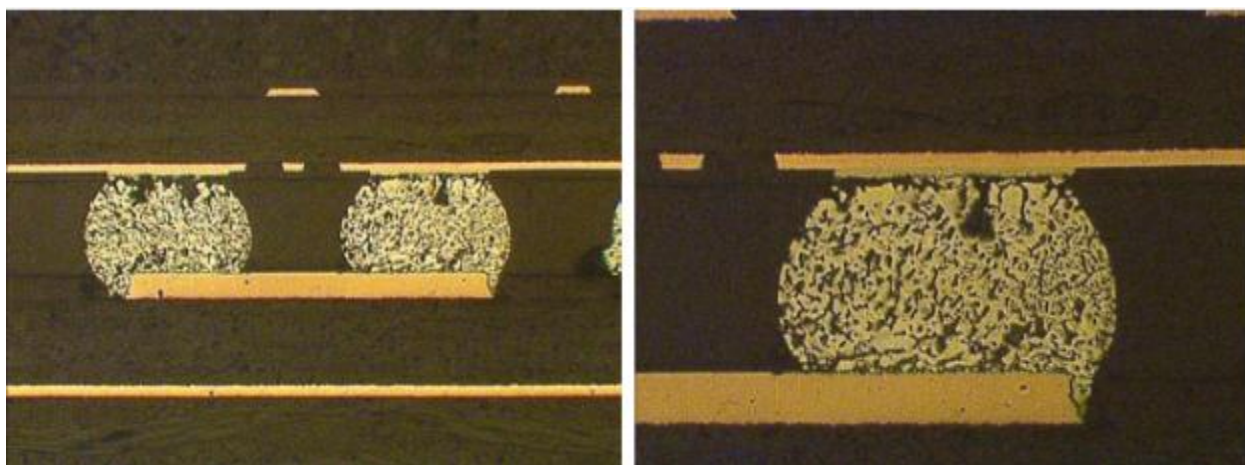
Figure 166 - CSP-100 Solder Joints, Board 103, Component U33, SN100C/SnPb, Failed @ 2932 Cycles

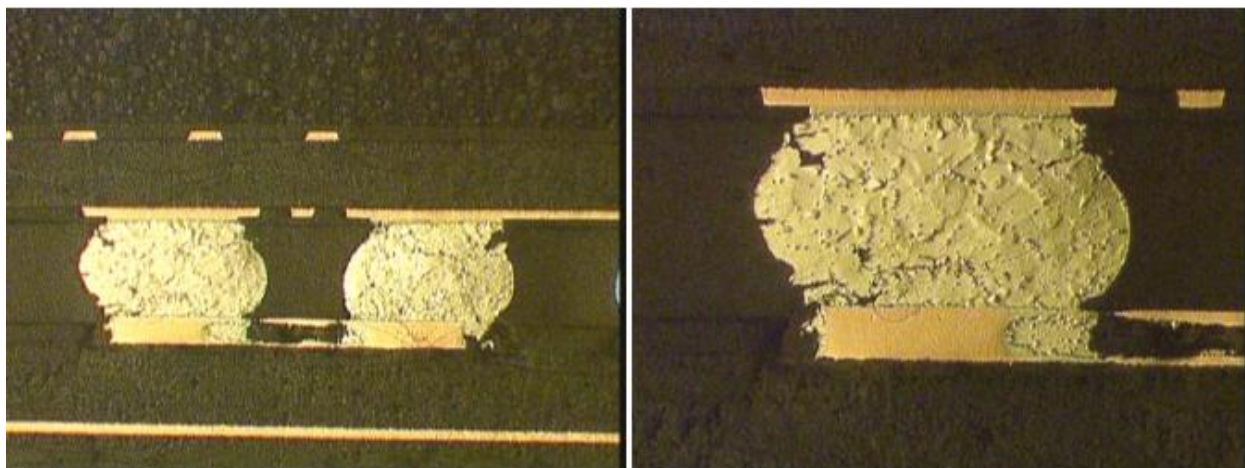
Figure 167 - CSP-100 Solder Joints, Board 106, Component U36, SN100C/SAC105, Failed @ 3908 Cycles

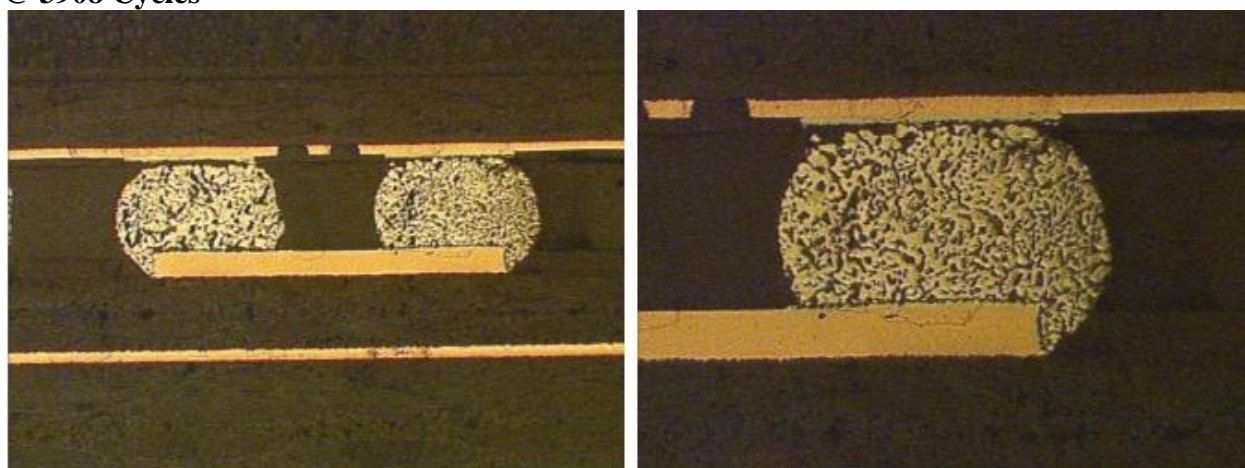
Figure 168 - Reworked CSP-100 Solder Joints, Board 128, Component U19, Initially SnPb/SnPb, 1 rework Flux Only/SnPb, Failed @ 3012 Cycles

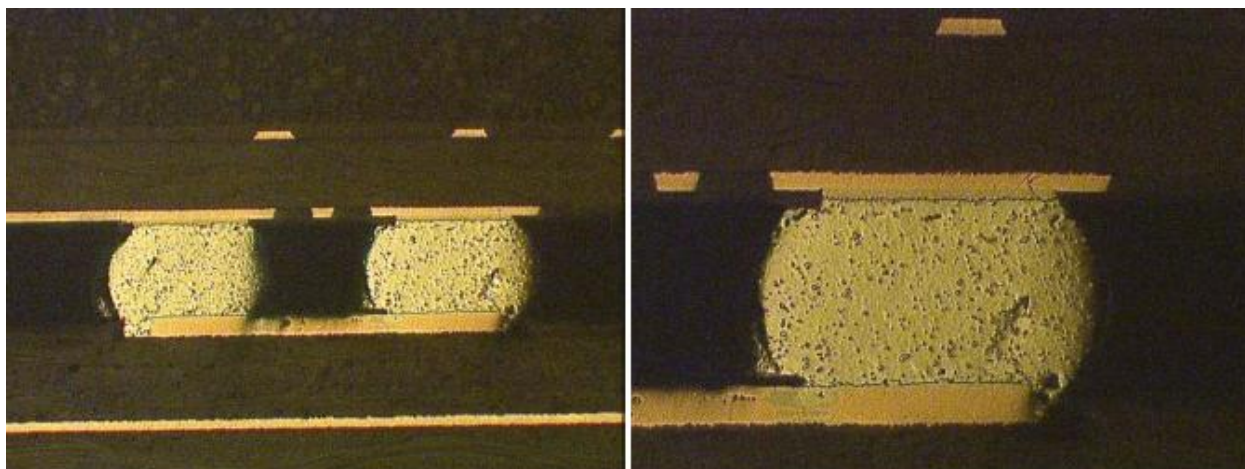
Figure 169 - Reworked CSP-100 Solder Joints, Board 126, Component U60, Initially SnPb/SnPb, 1 rework SnPb/SAC105, DNF

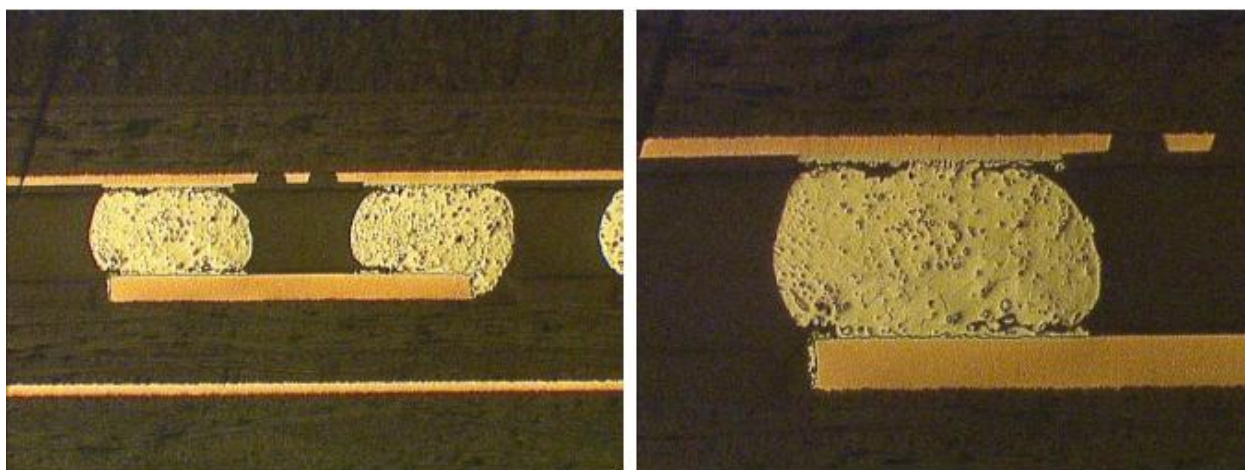
Figure 170 - Reworked CSP-100 Solder Joints, Board 168, Component U19, Initially SAC305/SAC105, 1 rework Flux Only/SAC105, DNF

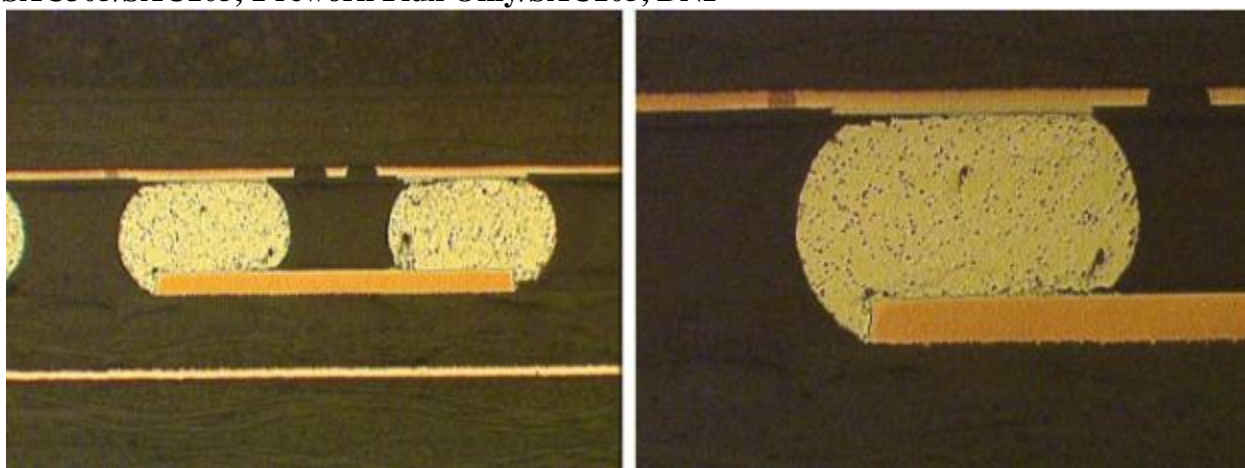
Figure 171 - Reworked CSP-100 Solder Joints, Board 164, Component U33, Initially SAC305/SAC105, 1 rework SnPb/SAC105, DNF

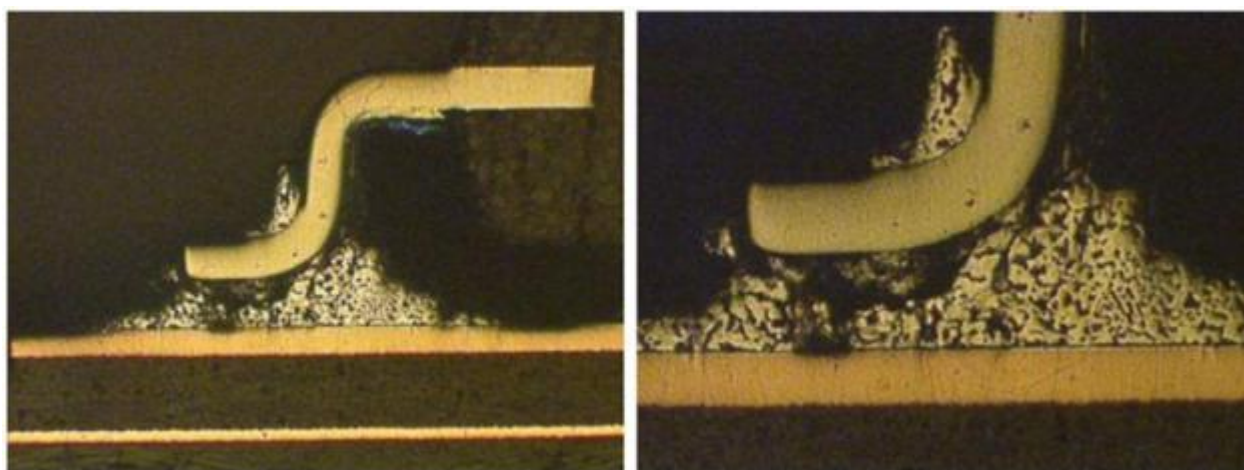
- The cracks in the solder joints initiated in the heel fillet region and traversed under the foot towards the lead toe. The crack formation and location are in agreement with industry knowledge of Alloy 42 TSOP failure modes (9).

Figure 176 - TSOP-50 Solder Joints, Board 8, Component U40, SnPb/SnPb, Failed @ 1252 Cycles

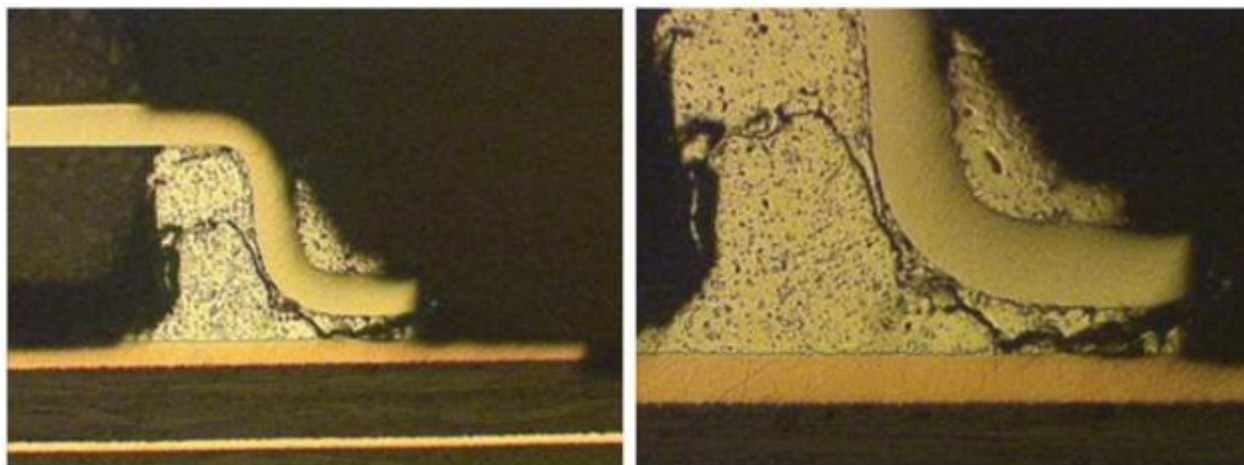
Figure 177 - TSOP-50 Solder Joints, Board 44, Component U25, SAC305/SnPb, Failed @ 1787 Cycles

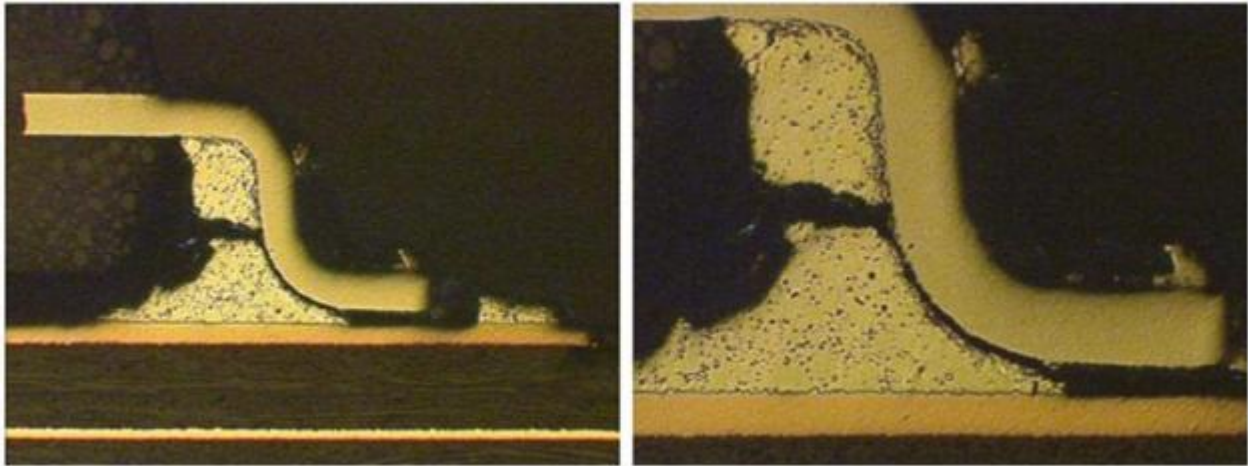
Figure 178 - TSOP-50 Solder Joints, Board 103, Component U39, SN100CSnPb, Failed @ 851 Cycles

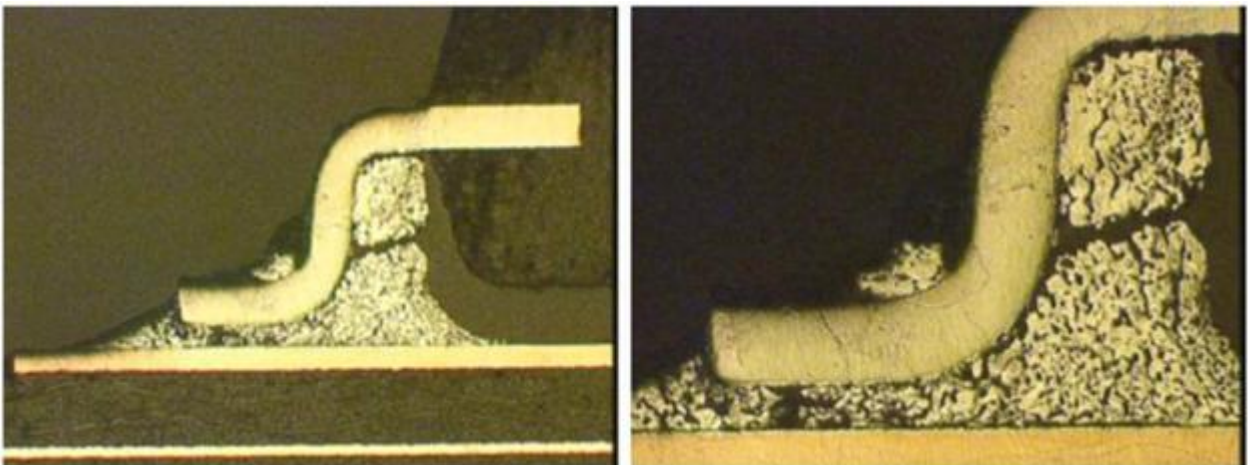
Figure 179 - TSOP-50 Solder Joints, Board 8, Component U29, SnPb/SnBi, Failed @ 1424 Cycles

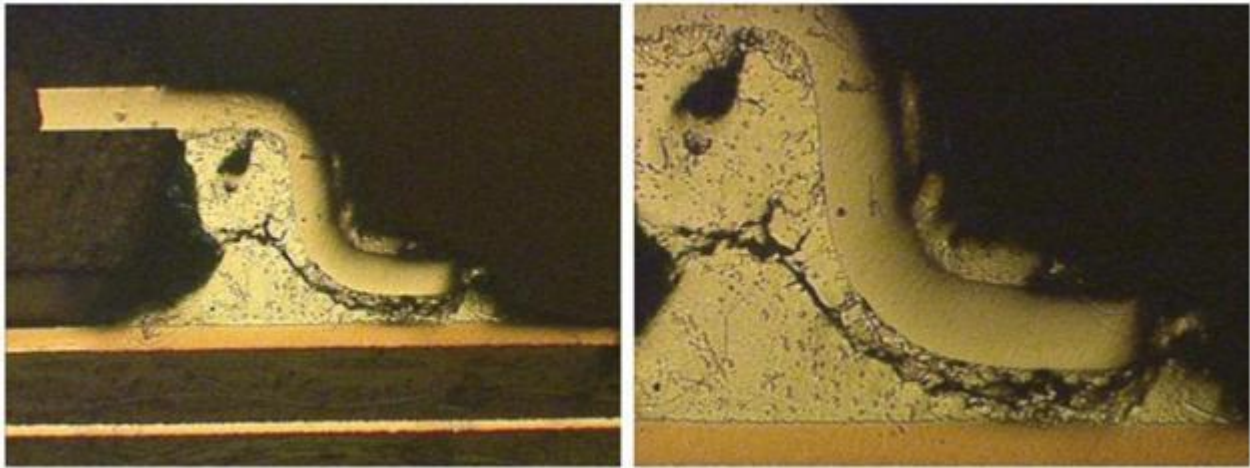
Figure 180 - TSOP-50 Solder Joints, Board 166, Component U39, SAC305/SnBi, Failed @ 1594 Cycles

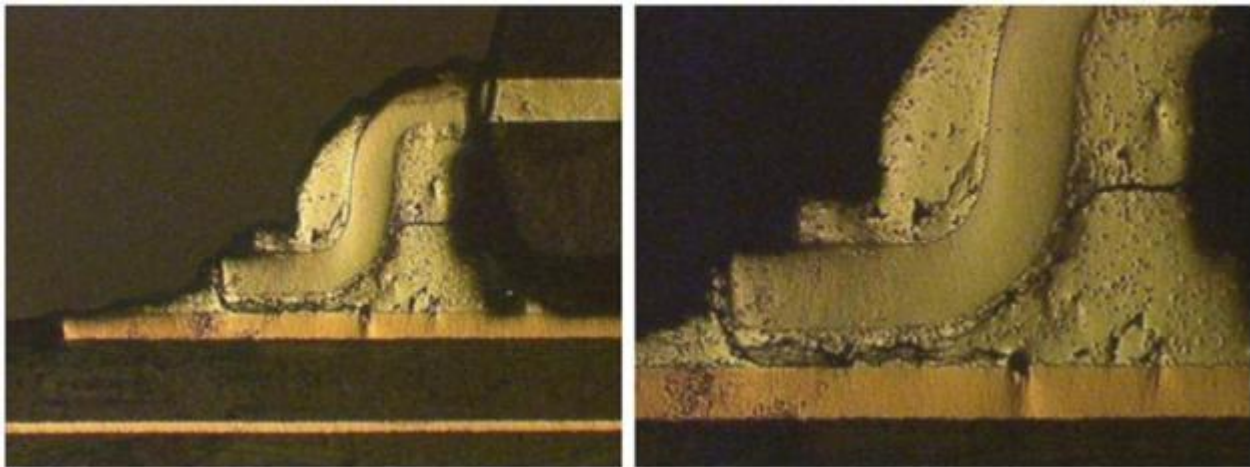
Figure 181 - TSOP-50 Solder Joints, Board 102, Component U34, SN100C/SnBi, Failed @ 1985 Cycles

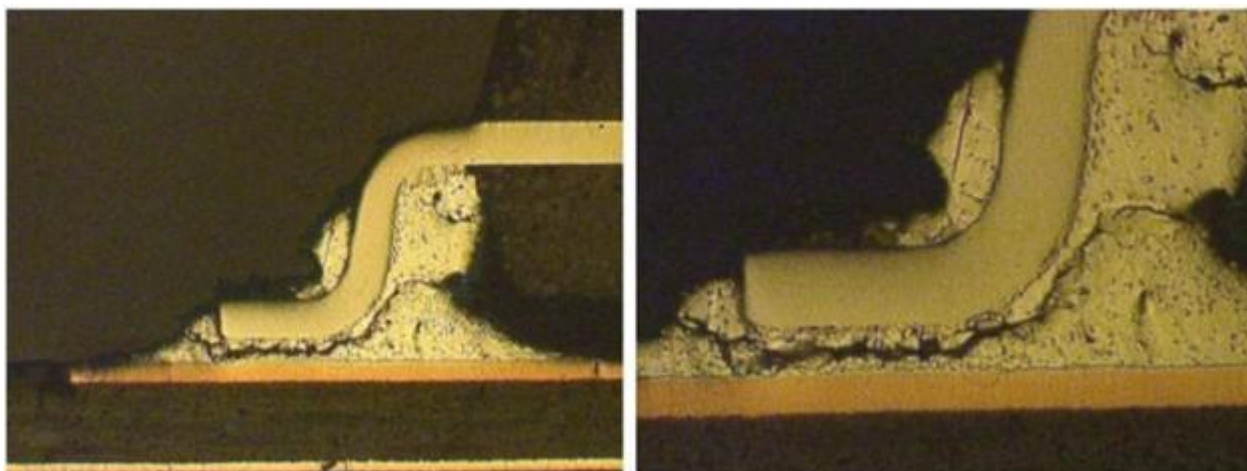
Figure 182 - TSOP-50 Solder Joints, Board 107, Component U61, SN100C/Sn, Failed @ 1258 Cycles

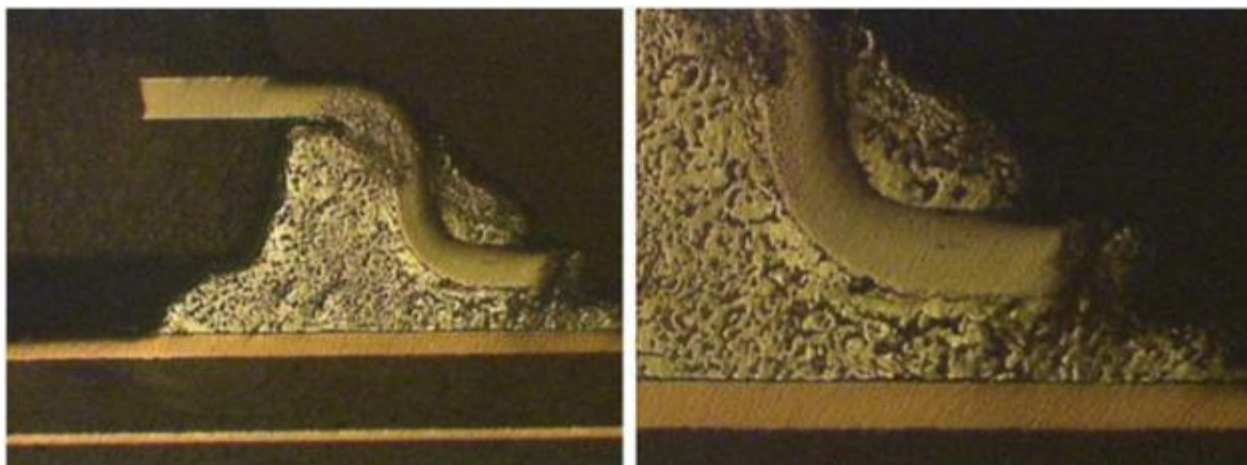
Figure 183 - Reworked TSOP-50 Solder Joints, Board 127, Component U12, Initially SnPb/SnPb, 1 rework SnPb/SnPb, Failed @ 1443 Cycles

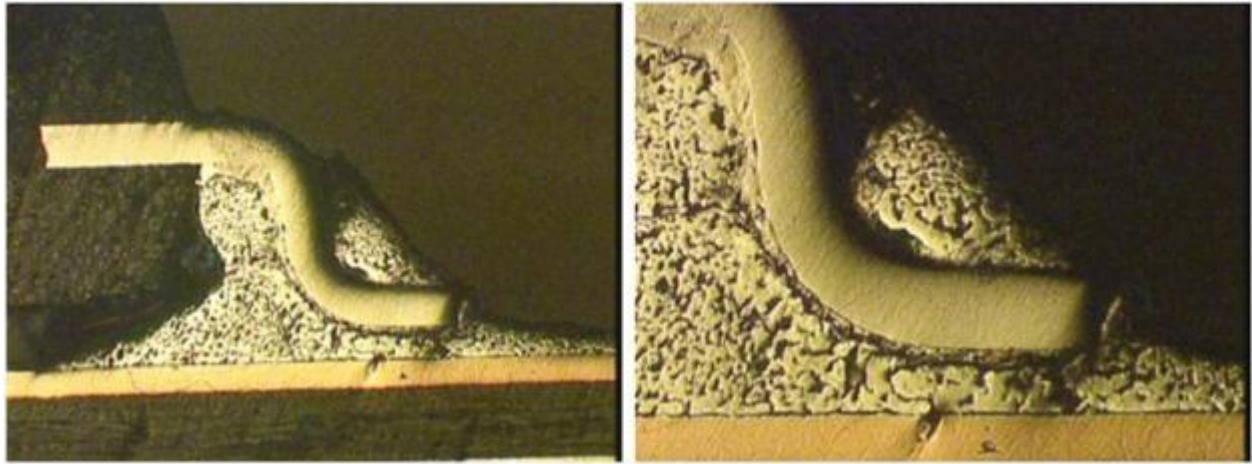
Figure 184 - Reworked TSOP-50 Solder Joints, Board 47, Component U24, Initially SAC305/SnBi, 2 rework SnPb/SnBi, Failed @ 1810 Cycles

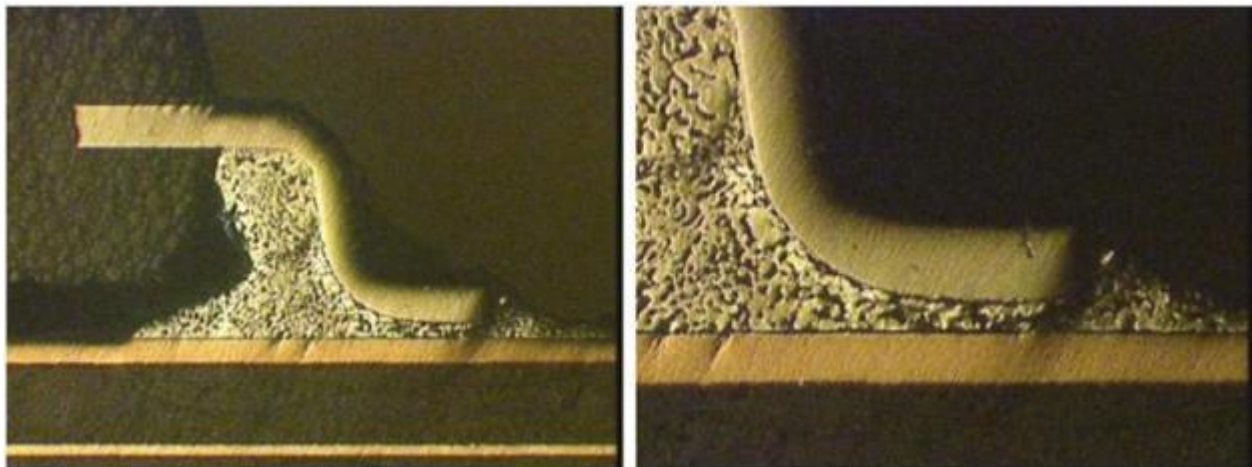
Figure 185 - Reworked TSOP-50 Solder Joints, Board 47, Component U29, Initially SAC305/Sn, 1 rework SnPb/Sn, Failed @ 1010 Cycles

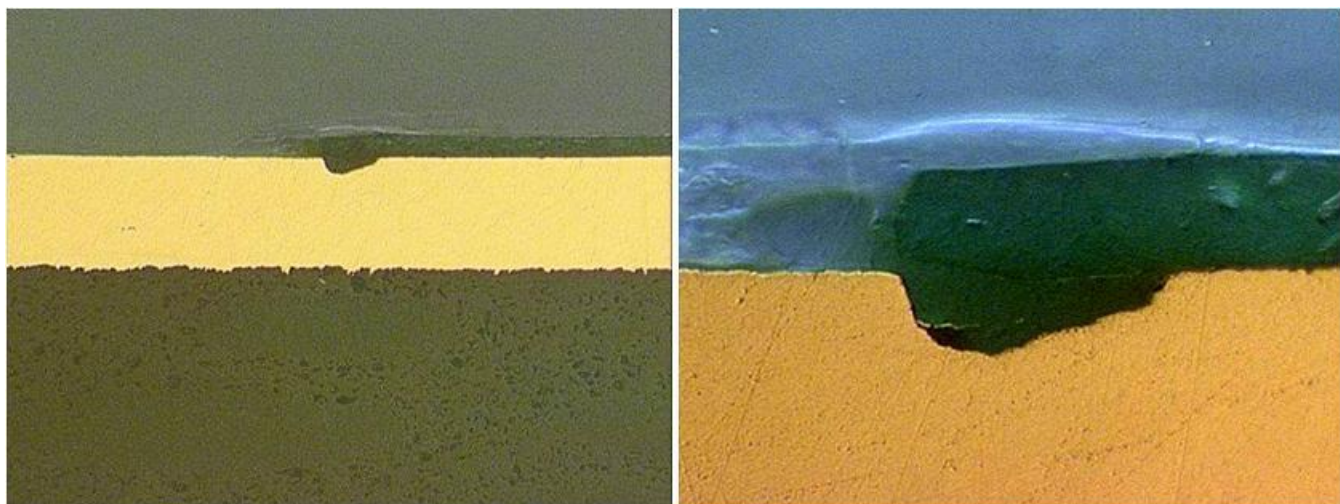
Metallographic cross-sectional analysis was conducted on the PDIP-20 components to document the solder joint failure location, crack morphology and solder joint microstructure. One of the issues observed during the NASA DoD testing program was the significant solder joint integrity difference in the PDIP-20 components in comparison with the JCCA/JGGP testing program results. Failure analysis reviewed a fabrication defect in the test vehicle associated with the surface traces for the PDIP-20 components. Poor cleaning/entrapment of fabrication chemistry resulted in the removal of copper beneath the soldermask. Figure 191 and Figure 192 shows a cross-sectional view of the fabrication defect in the test vehicle at the PDIP-20 locations. Fabrication chemistry was trapped under the soldermask edge along the PDIP-20 pads resulting in a reduction of the copper trace thickness.

Figure 191 - Cross-sectional Views of the Fabrication Defect in the Test Vehicle at the PDIP-20 Locations (Left – Macro View, Right – Magnified View)

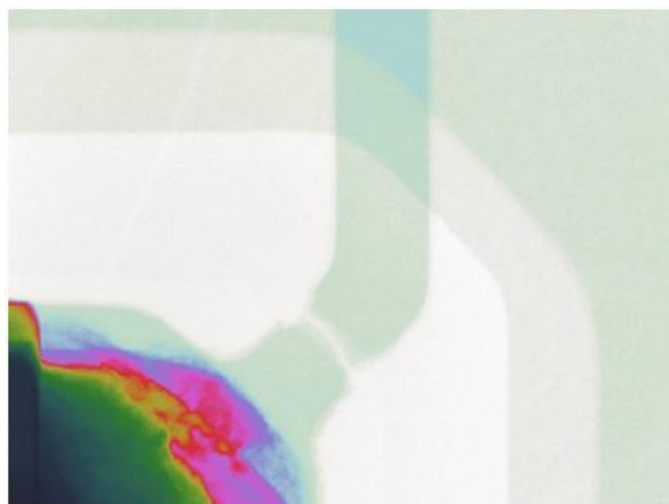
Figure 192 - Color X-ray Image of PDIP-20 Thermal Cycling Induced Cracked Trace

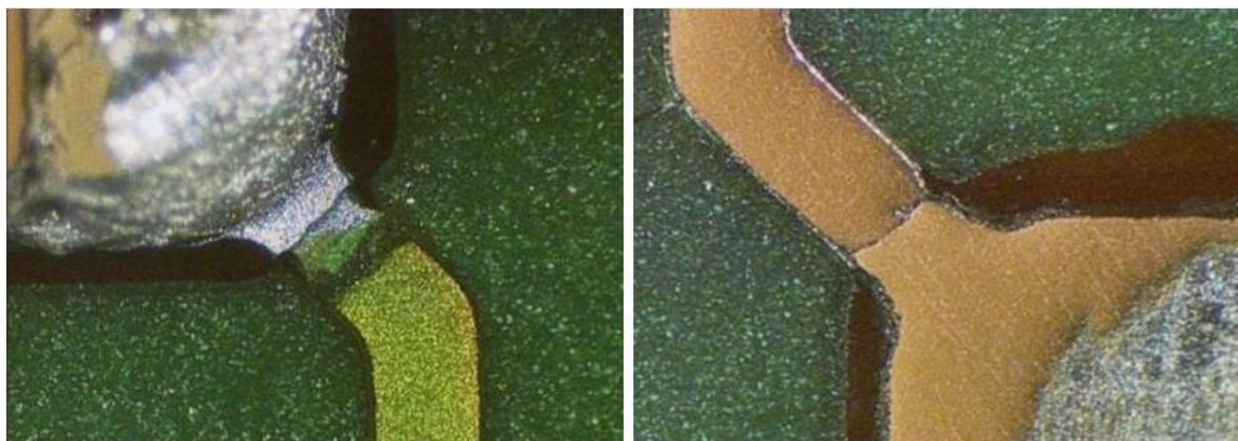
This “necked down” region of the trace cracked during thermal cycling. In addition, the lead-free solder alloys had additional trace integrity degradation due to their copper dissolution characteristics. Figure 193 illustrates the resulting trace cracks due to thermal cycle testing of a PDIP-20 component.

Figure 193 - PDIP-20 Thermal Cycling Induced Cracked Trace at Fabrication Defect Location

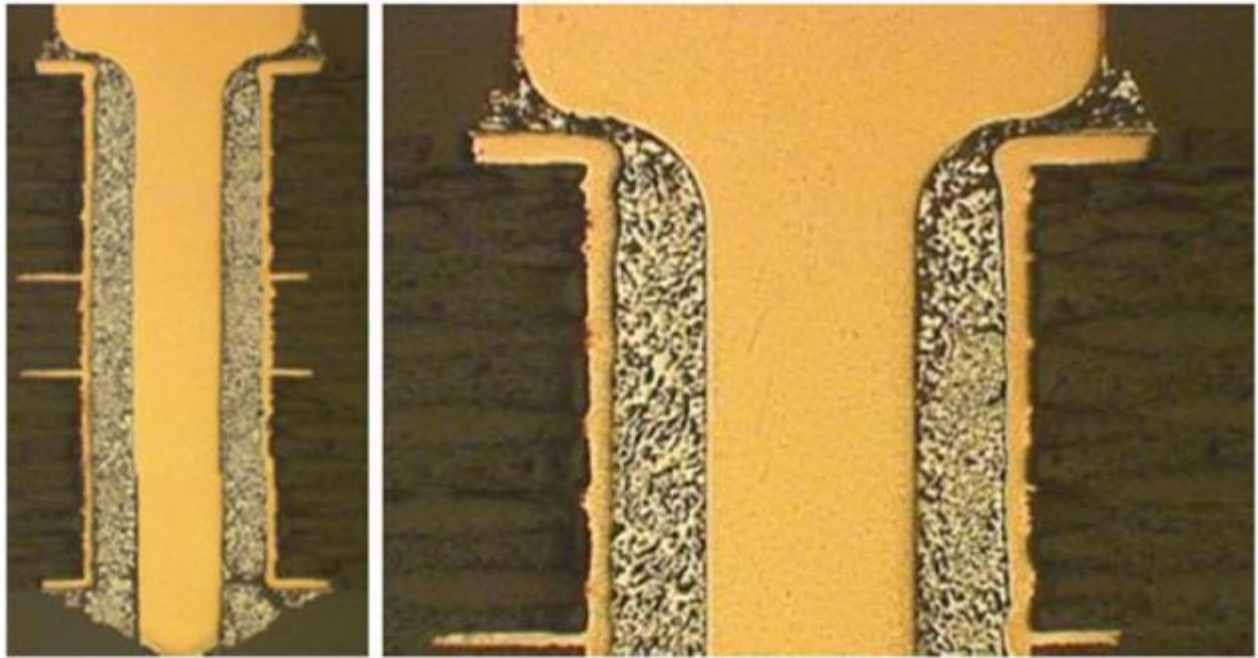
- The cracks in the solder joints initiated in the heel fillet region and traversed under the foot towards the lead toe. The crack formation and location are in agreement with industry knowledge of PDIP failure modes (11).
- The solder joint geometries and wetting angles were acceptable and met industry workmanship criteria. There were a number of instances where the solder did flow into the upper lead bend region which is acceptable per industry standards.
- The solder joint microstructures were reasonably homogenous with no segregation regions observed in the mixed metallurgy cases.

Figure 194 through Figure 196 illustrate the typical TSOP-50 solder joint failures. Note that the “failed cycle” value is when the copper trace broke and not a failure of the solder joint in these figures.

Figure 194 - PDIP-20 Solder Joints, Board 124, Component U23, SnPb/NiPdAu, DNF

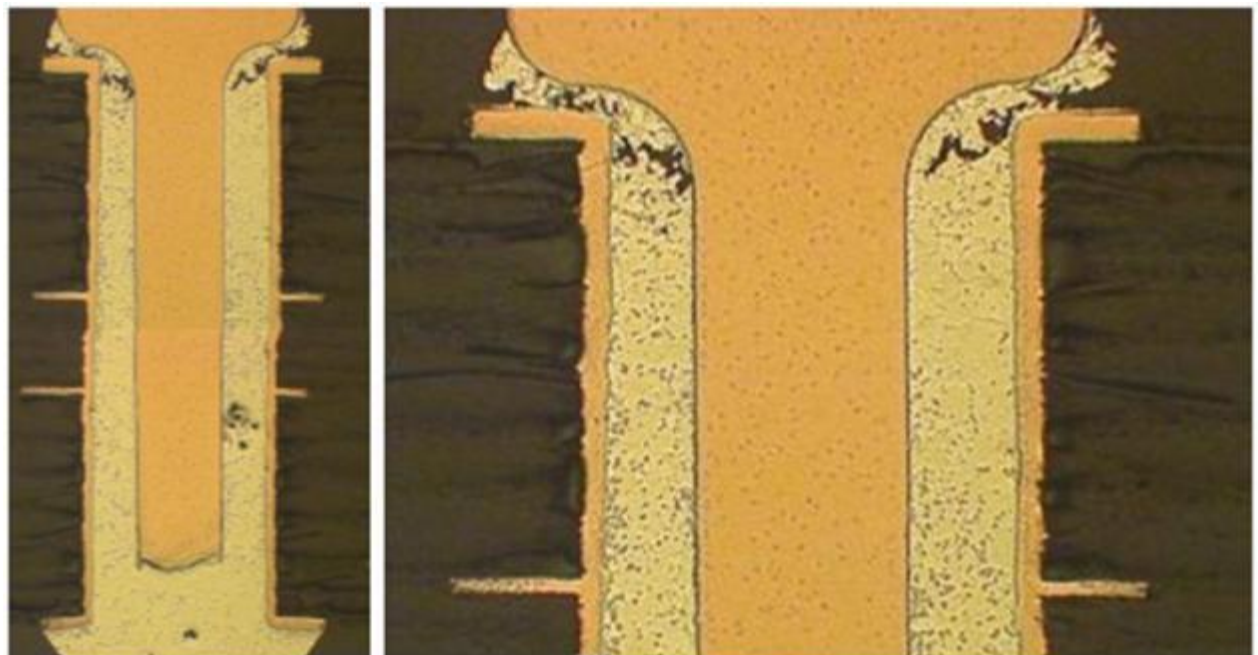
Figure 195 - PDIP-20 Solder Joints, Board 43, Component U8, SN100C/NiPdAu, DNF

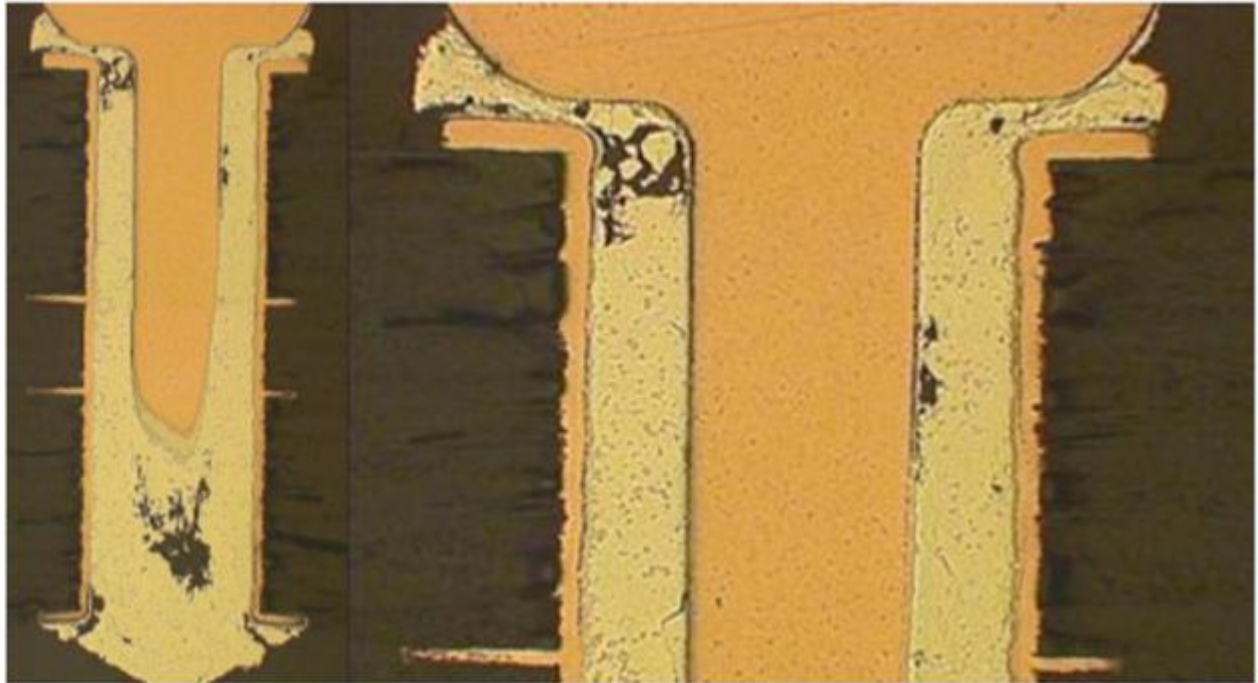
Figure 196 - PDIP-20 Solder Joints, Board 168, Component U49, SN100C/Sn, DNF

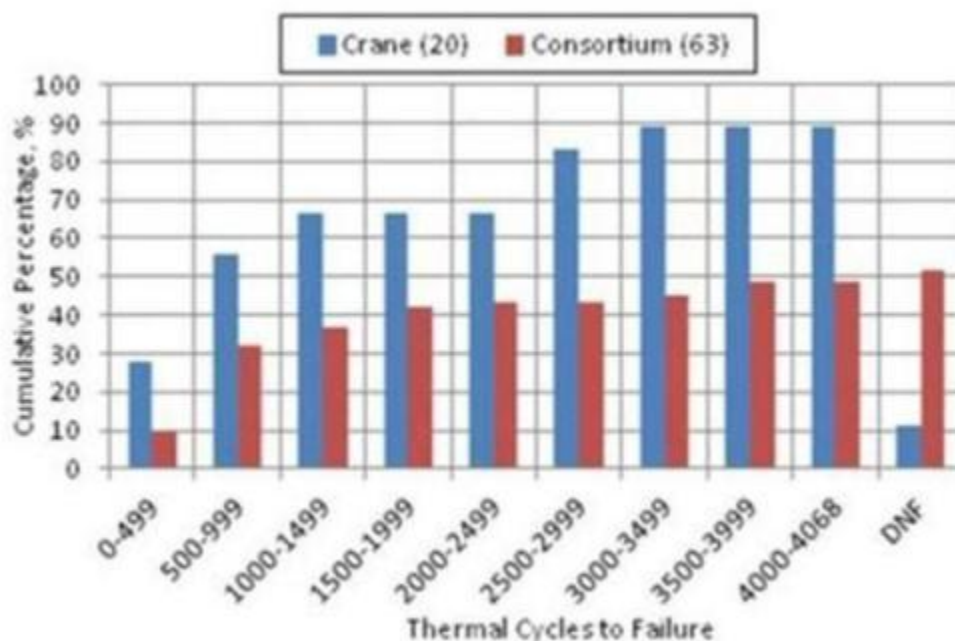
All reworked PDIP's came from batches F and I. As previously discussed in section 3.1, a production issue resulted in PDIP's from both of these batches and batch G being less reliable than PDIP's from batches A, B, C, and E. The increased rate of failure is illustrated in Figure 202 and Figure 203 and shown in Table 35. This production issue convolutes the meaning of both the percent of components that failed during testing, shown in Table 33 and the p-values, shown in Table 34.

Figure 202 - Cumulative Percentage of failures for as-manufactured Sn finished PDIP's soldered with SN100C showing a faster rate of failure and higher overall rate of failure for PDIP's on Crane test vehicles vs. other test vehicles in the consortium. There were 20 Crane specific PDIPs vs. 63 general to the consortium.

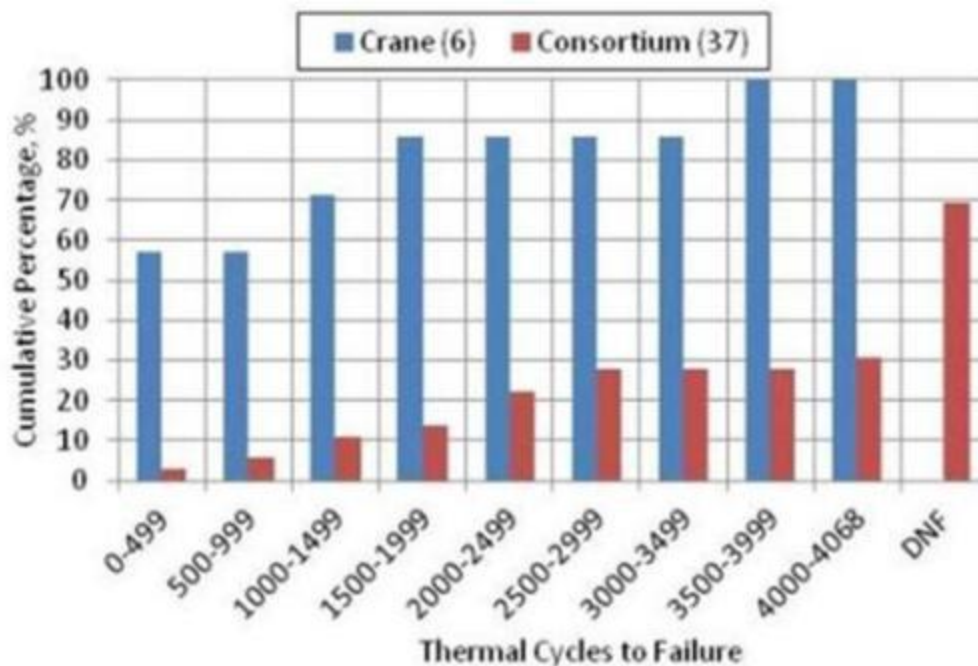
Figure 203 - Cumulative Percentage of failures for as-manufactured NiPdAu finished PDIP's soldered with SN100C showing a faster rate of failure and higher overall rate of failure for PDIP's on Crane test vehicles vs. other test vehicles in the consortium. There were 6 Crane specific PDIPs vs. 37 general to the consortium.

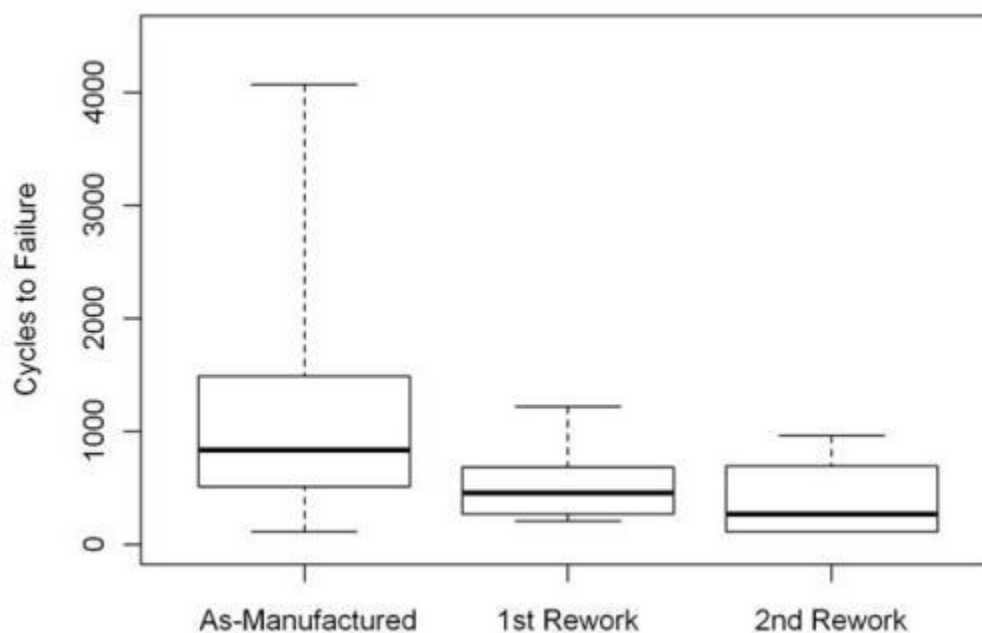
A repeat analysis of the PDIP cycles to failure was performed, only considering PDIP's from batches F, G, and I. All differences that were previously statistically significant were still determined to be statistically significant. However, the average cycles to failure for Sn finished PDIP's soldered with SN100C decreased from 2398 cycles to 1228 cycles; the average cycles to failure for NiPdAu finished PDIP's soldered with SN100C decreased from 3027 cycles to 2120 cycles. An example of the change in the box and whisker plot for Sn finished PDIP's soldered with SN100C is shown in Figure 204; and example of the change in the box and whisker plot for NiPdAu finished PDIP's soldered with SN100C is shown in Figure 205.

Figure 204 - Recreated box and whisker plot comparing thermal cycles to failure for Sn finished PDIP's originally soldered with SN100C and reworked 1 or 2 times with Sn finished PDIP's soldered with eutectic SnPb showing the effect of only considering times to failure from batches F, G, and I.

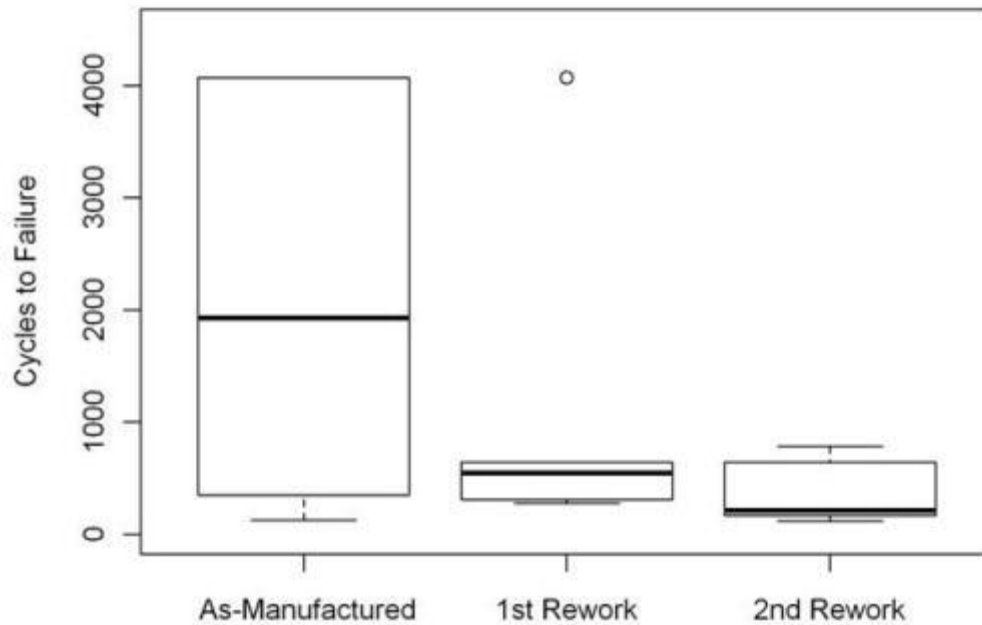
Figure 205 - Recreated box and whisker plot comparing thermal cycles to failure for NiPdAu finished PDIP's originally soldered with SN100C and reworked 1 or 2 times with Sn finished PDIP's soldered with eutectic SnPb showing the effect of only considering times to failure from batches F, G, and I.

Overall, it is difficult to determine the true effect of reworking PDIP's on the thermal cycles to failure. There is a significant decrease in cycles to failure for reworked PDIP's compared to the as-manufactured PDIP's. However, a production issue affecting reworked PDIPS's convoluted the results. Further testing is required to determine the effect of rework on PDIP's.

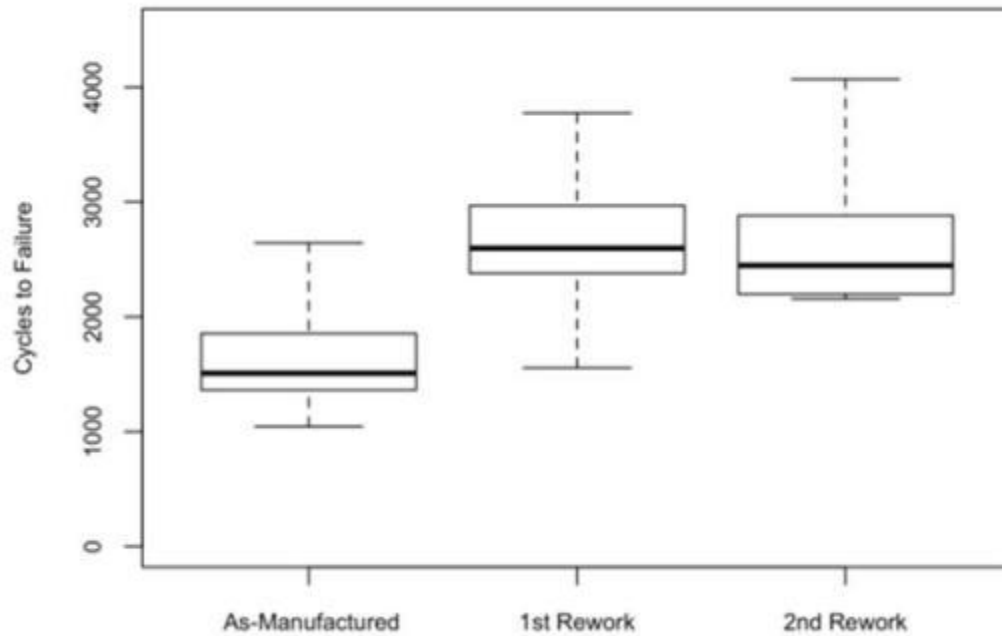
Both rework scenarios resulted in reworked TQFP's with a statistically significant increase in thermal cycles to failure comparable to the as-manufactured TQFP's. Reworking Sn finished TQFP's originally soldered with SAC305 resulted in an increase in cycles to failure from 1630 cycles to 2677 cycles after one rework and 2705 cycles after two reworks; reworking Sn finished TQFP's originally soldered with SN100C resulted in an increase in cycles to failure from 1634 cycles to 2436 cycles after one rework and 2697 cycles after two reworks. The p-values, shown in Table 34, were all less than 0.05. The percentages of components that failed during testing, shown in Table 33, were all within expected variation.

Figure 206 - Box and whisker plot comparing thermal cycles to failure for Sn finished TQFP's originally soldered with SAC305 and reworked 1 or 2 times with Sn finished TQFP's soldered with eutectic SnPb. The increase in cycles to failure for both reworks was considered statistically significant.

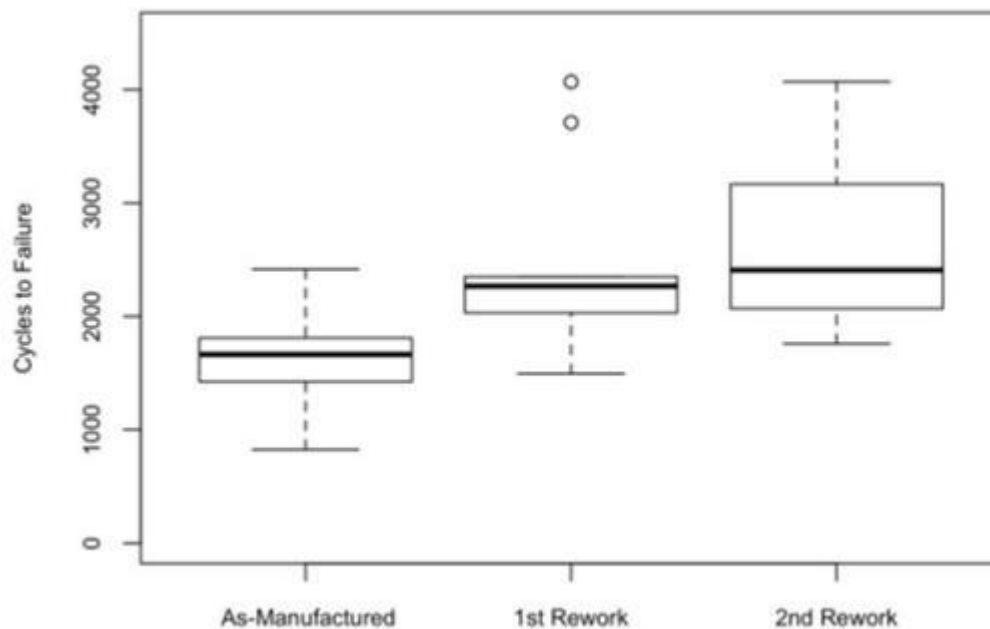
Figure 207 - Box and whisker plot comparing thermal cycles to failure for Sn finished TQFP's originally soldered with SN100C and reworked 1 or 2 times with Sn finished

TQFP's soldered with eutectic SnPb. The increase in cycles to failure for both reworks was considered statistically significant.

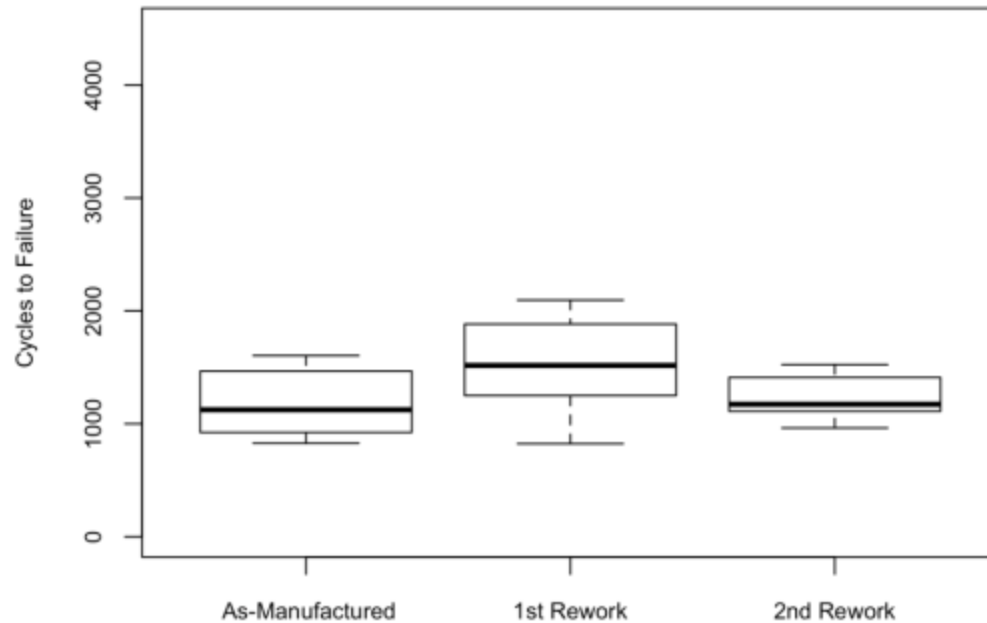
The rework scenarios resulted in reworked TSOP's that were either equivalently or more reliable during thermal cycling testing when compared to the as-manufactured TSOP's. Reworked Sn finished TSOP's originally soldered with SN100C, increasing from 1044 cycles to 1367 cycles after the first rework and 1298 after the second rework. Reworked SnBi finished TSOP's, originally soldered with SAC305, increased from 1204 cycles to 1508 cycles after the second rework. All other differences between the as-manufactured and reworked cycles to failure were not considered statistically significant. There was a statistically significant decrease in cycles to failure between the first and second rework of Sn finished TSOP's originally soldered with SAC305, but this trend was not observed for any other TSOP chemistry, nor was it observed for any other component type.

Figure 208 - Box and whisker plot comparing thermal cycles to failure for Sn finished TSOP's originally soldered with SAC305 and reworked 1 or 2 times with Sn finished TSOP's soldered with eutectic SnPb. No differences in cycles to failure between the as-manufactured and reworked conditions were considered statistically significant, but the decrease in cycles to failure between the 1st and 2nd rework was considered significant.

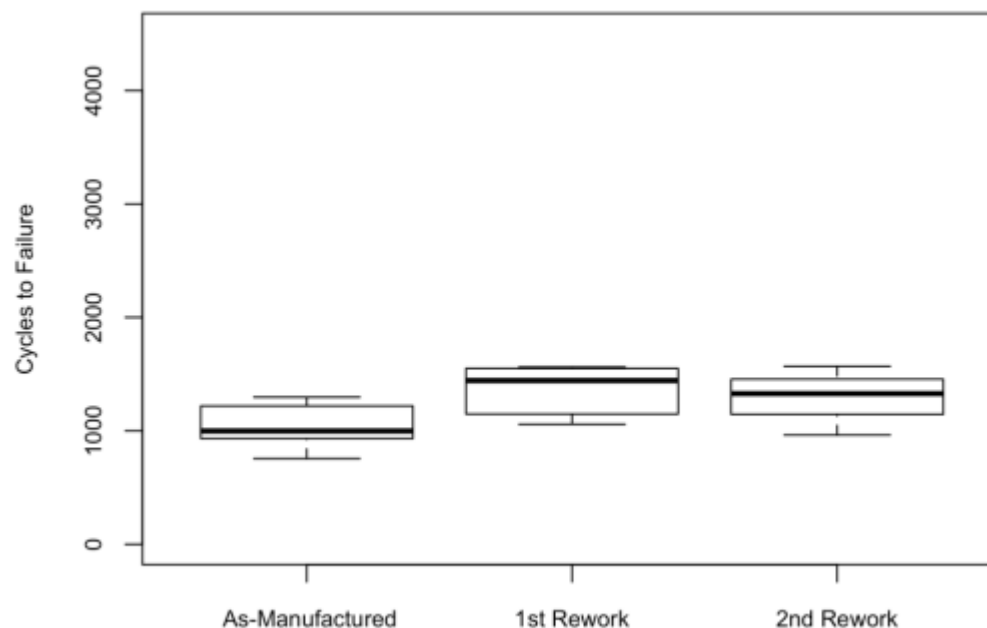
Figure 209 - Box and whisker plot comparing thermal cycles to failure for Sn finished TSOP's originally soldered with SN100C and reworked 1 or 2 times with Sn finished TSOP's soldered with eutectic SnPb. No differences in cycles to failure between the as-manufactured and reworked conditions were considered statistically significant, but the decrease in cycles to failure between the 1st and 2nd rework was considered significant.

TSOP's soldered with eutectic SnPb. The increase in cycles to failure for both reworks was considered statistically significant.

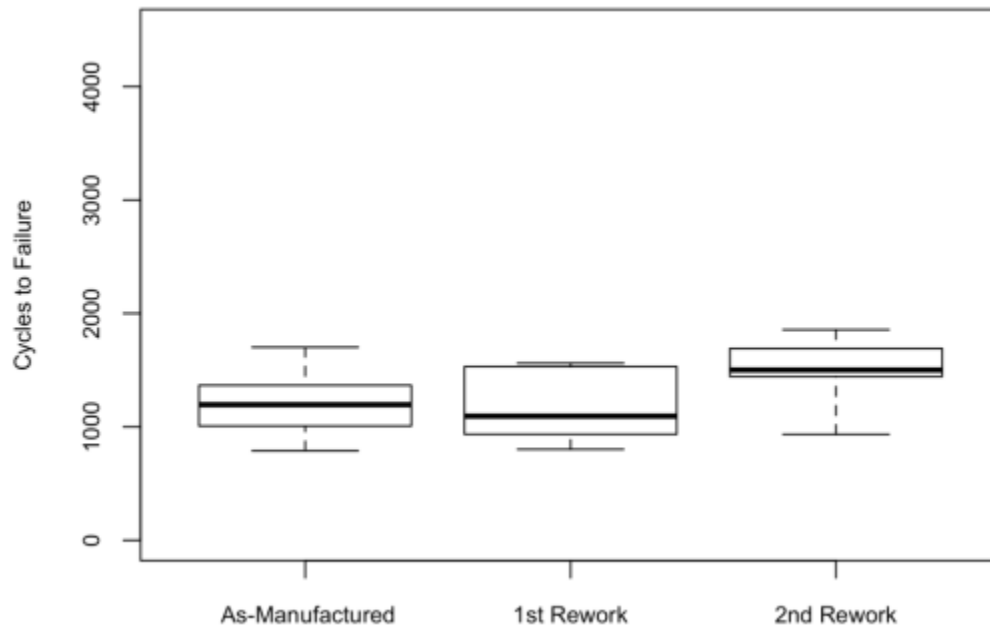
Figure 210 - Box and whisker plot comparing thermal cycles to failure for SnBi finished TSOP's originally soldered with SAC305 and reworked 1 or 2 times with SnBi finished TSOP's soldered with eutectic SnPb. Only the increase in cycles to failure for the 2nd rework was considered statistically significant.
